CO FURNACE REPAIR

Project Case Study

PROJECT TYPE:
FURNACE
REPAIR

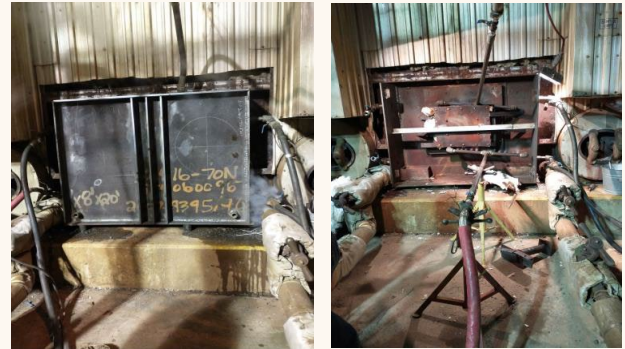
Temperatures exceeding 1100 degrees F and flu gases had been detected around a manway door on the side of the furnace. After an inspection was completed, it was determined that the area around the manway was compromised due to internal refractory failure. Management could not remove the heater from service without shutting the unit down thus requiring an online repair. The repair design included fabricating and welding 1/4" plates to the existing structure. HRI also assisted with the pumpable refractory.

- Enclosed the affected area over and around a manway door.
- Assisted with pumpable the refractory.

The project was completed safely, on time and on budget. HRI successfully installed the sections on the furnace side. By completing the repair on-line, the client was able to avoid a costly shutdown of the Unit and was able to return to normal production rates.
