SOOT BLOWER REPLACEMENT

Project Case Study

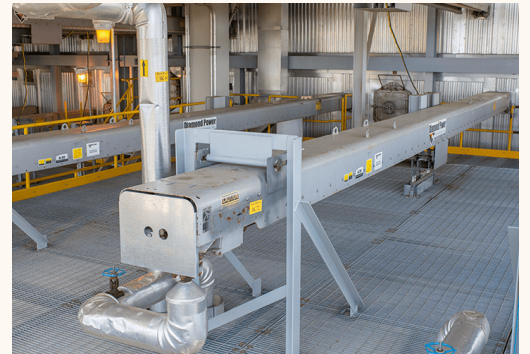
Utilizing HRI's Heat Safe System, our technicians were able to safely remove and replace all seven soot blowers. In addition to replacing the soot blowers, HRI also inspected and repaired the steam lines, wall box seal assemblies, and other associated equipment.

HRI developed a plan to remove and replace all 7 soot blowers while the FCCU was operational. The internal temperature and pressure of the unit was approximately 850° F and 1.0 psig.
